December 23, 2023

**Subject: Report of Initial Findings - A5 Environmental Project No.: 122023-01**

On December 20, 2023, A5 Environmental visited the residence at 1315 Ameluxen Ave Hacienda Heights, CA 91745 to conduct a Mold Assessment. The limited asbestos survey was only performed on materials that may be removed from the scope of report as described in this report.

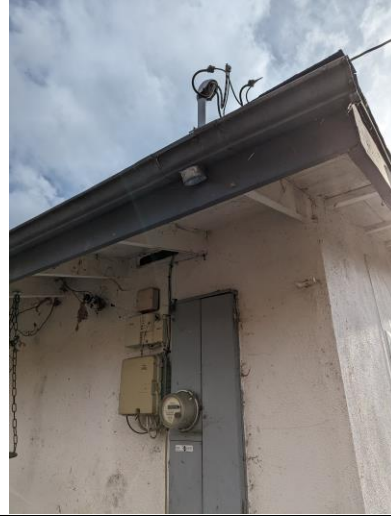
- Downspouts are not present.

No downspouts

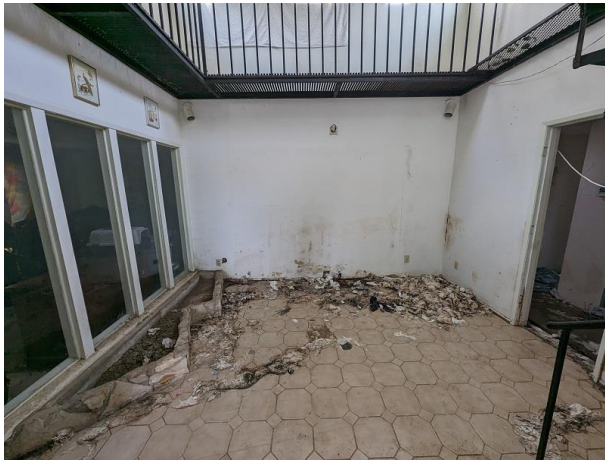
- Debris and rubbish were observed throughout the residence floors.

Debris throughout floor

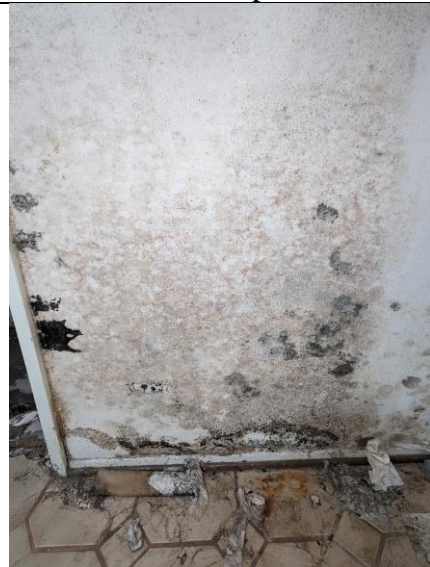
Mold growth

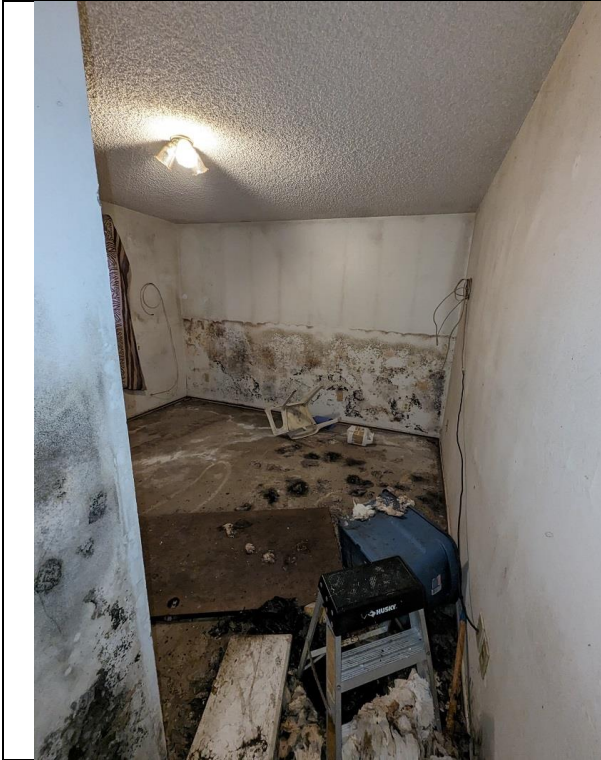
- Suspect mold growth was observed throughout.
- Tape lift sample was collected.

In the Master Bedroom, samples were collected on the west wall. Mold was observed on all walls as well as the floor and ceiling. Samples showed Chaetomium and Penicillium/Aspergillus growth. Due to these findings, mold remediation is recommended.

Master bedroom mold growth

- Remove all debris.
- Remove all walls.
- Remove entire ceiling.
- Remove and dispose of insulation and any debris found within exposed wall cavities.
- Exposed wooden structural members exhibiting staining should be sanded, wire brushed, HEPA vacuumed, damp wiped and HEPA vacuumed again.
- The remedial contractor should observe the backside of removed wall materials and carefully evaluate for growth into adjacent areas. The contractor should also use a mirror to look up, down and to the side of the still covered wall and ceiling cavities. The observation of growth warrants the removal of the affected drywall to extend two feet beyond visible mold growth.

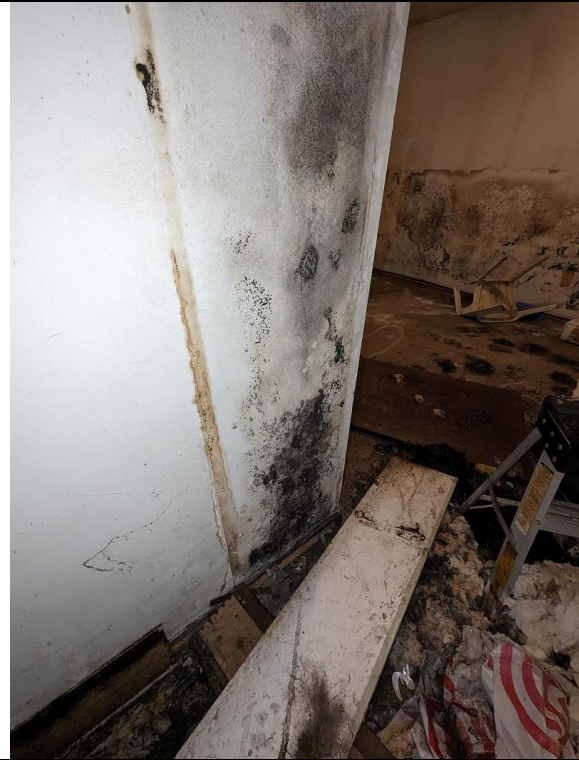
Mold growth

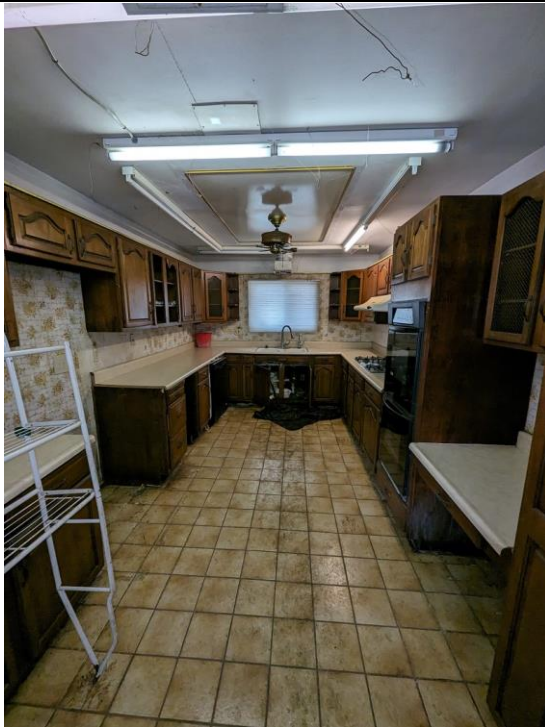
Kitchen

- Water damage was observed in the kitchen sink cabinetry.
- Suspect mold growth was observed.
- Tape lift sample was collected.
- Ambient air sample was collected.

In the kitchen, water damage was observed around the kitchen sink cabinetry. Mold growth was observed and confirmed via laboratory analysis. Due to these findings, mold remediation is recommended. A sample was also collected from the dining room with elevations of mold spores.

- Remove all debris
- Remove all sink cabinetry.
- Remove North wall from floor to four feet.
- Remove and dispose of insulation and any debris found within exposed wall cavities.
- Exposed wooden structural members exhibiting staining should be sanded, wire brushed, HEPA vacuumed, damp wiped and HEPA vacuumed again.
- The remedial contractor should observe the backside of removed wall materials and carefully evaluate for growth into adjacent areas. The contractor should also use a mirror to look up, down and to the side of the still covered wall and ceiling cavities.

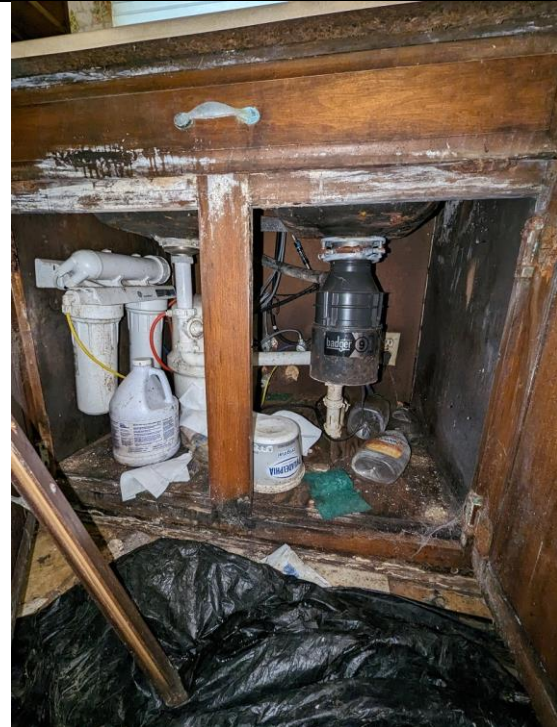
Water damage

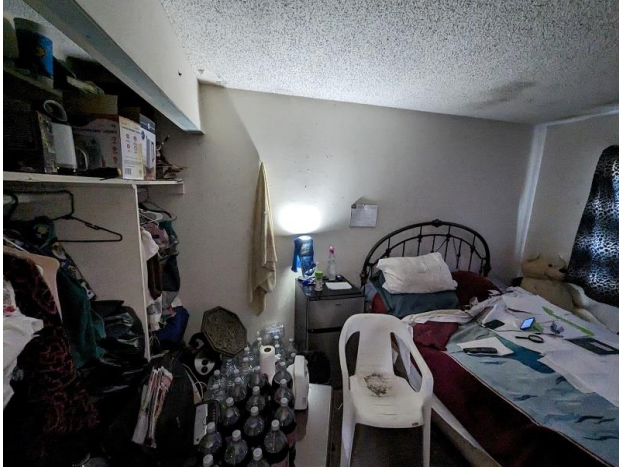
Bedroom

- Suspect mold growth was observed in Northwest wall.
- Elevations of moisture were detected in the flooring near the West wall.
- A tape lift sample was collected.

6. Perform the following remediation actions under negative air containment:
    - 6.1 Bedroom:
      - Remove a 4 x 4 foot section of wall from the Northwest corner containing mold.

- Remove and dispose of insulation and any debris found within exposed wall cavities.
      - Exposed wooden structural members exhibiting staining should be sanded, wire brushed, HEPA vacuumed, damp wiped and HEPA vacuumed again.

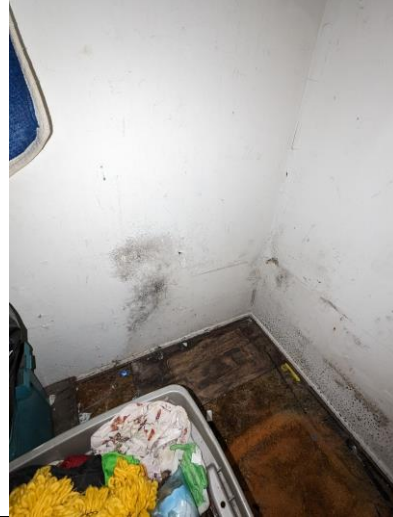
Mold growth

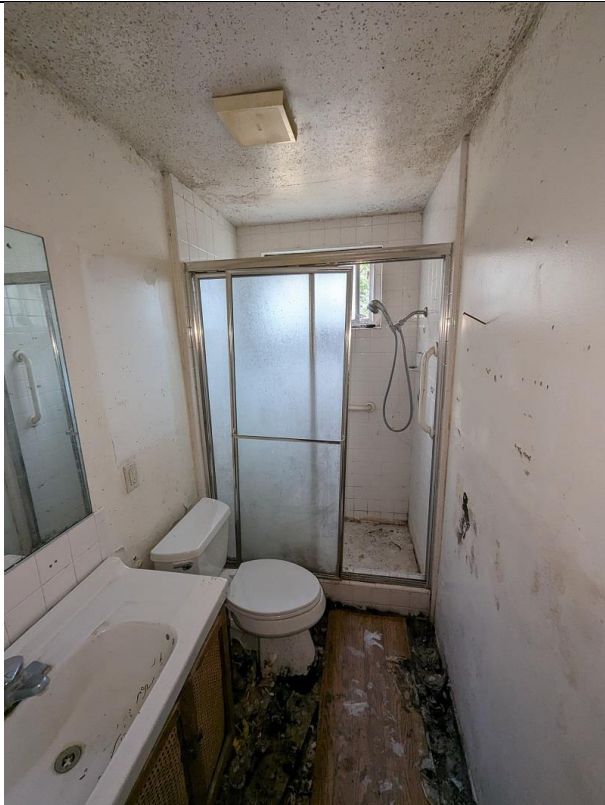
Master bathroom

In the bathroom on the south wall. Elevated moisture readings were detected. Visible mold was observed on the ceiling. Therefore, mold remediation is recommended.

- 6.2 Master bathroom:
      - Remove all debris
      - Remove all sink cabinetry.
      - Remove entire ceiling.
      - Remove north wall from floor to ceiling.

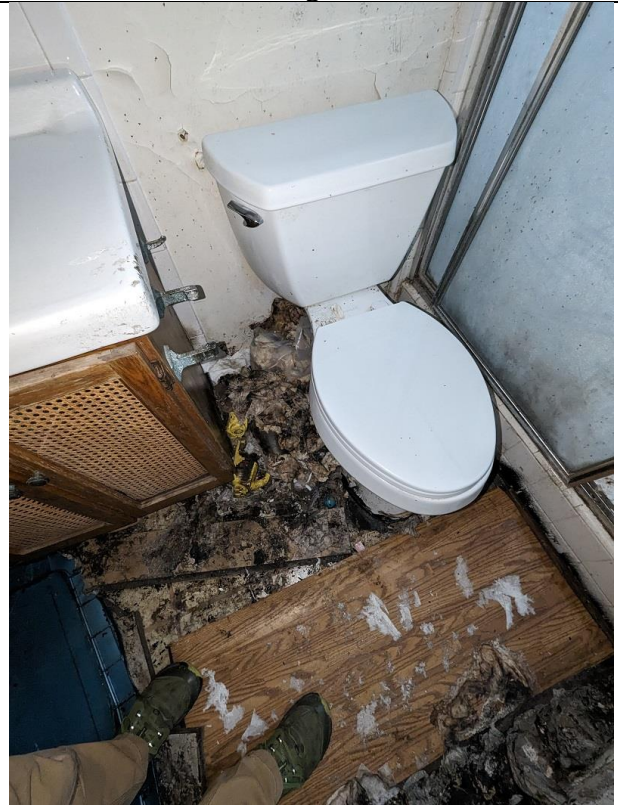
Debris throughout

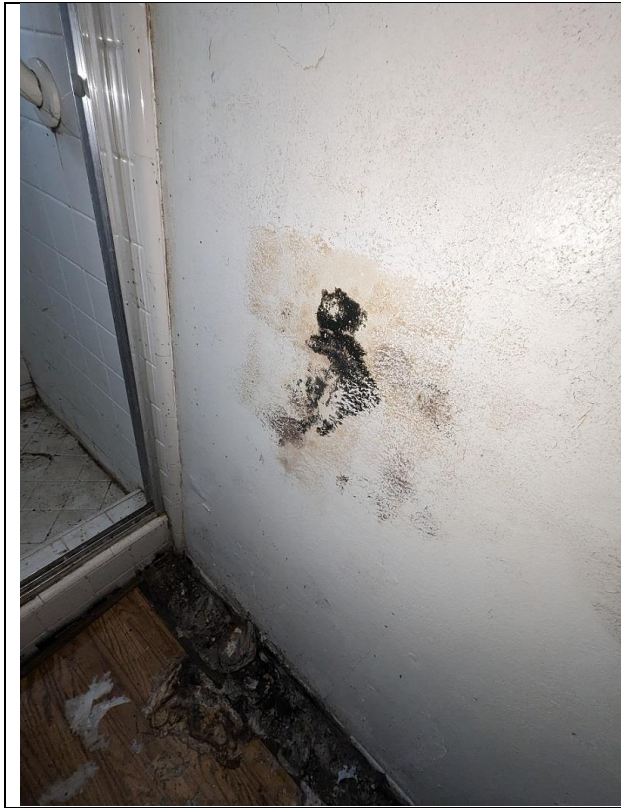
Mold growth

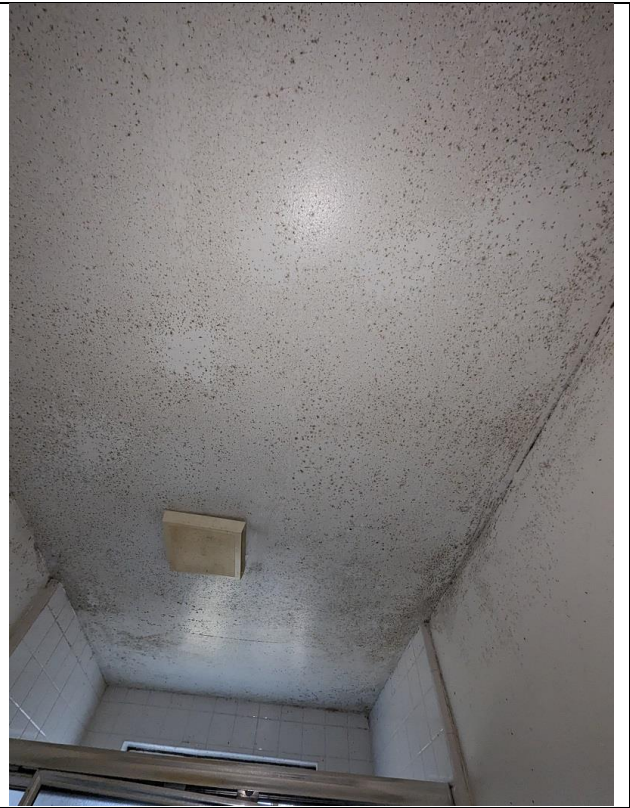
Mold growth
