December 23, 2023

**Subject: Report of Initial Findings - A5 Environmental Project No.: 122023-01**

On December 20, 2023, A5 Environmental visited the residence at 1315 Ameluxen Ave Hacienda Heights, CA 91745 to conduct a Mold Assessment. The limited asbestos survey was only performed on materials that may be removed from the scope of report as described in this report.

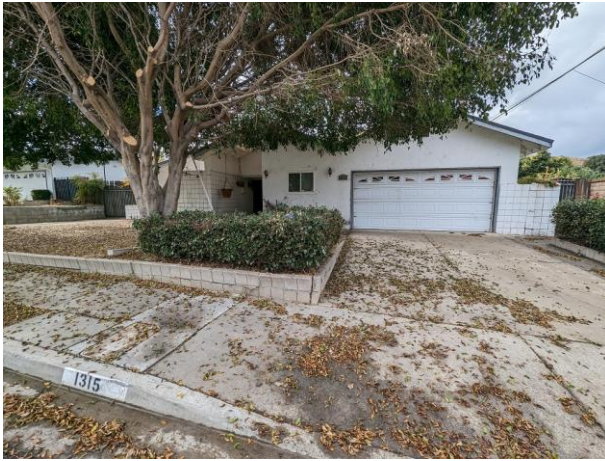
Front of residence

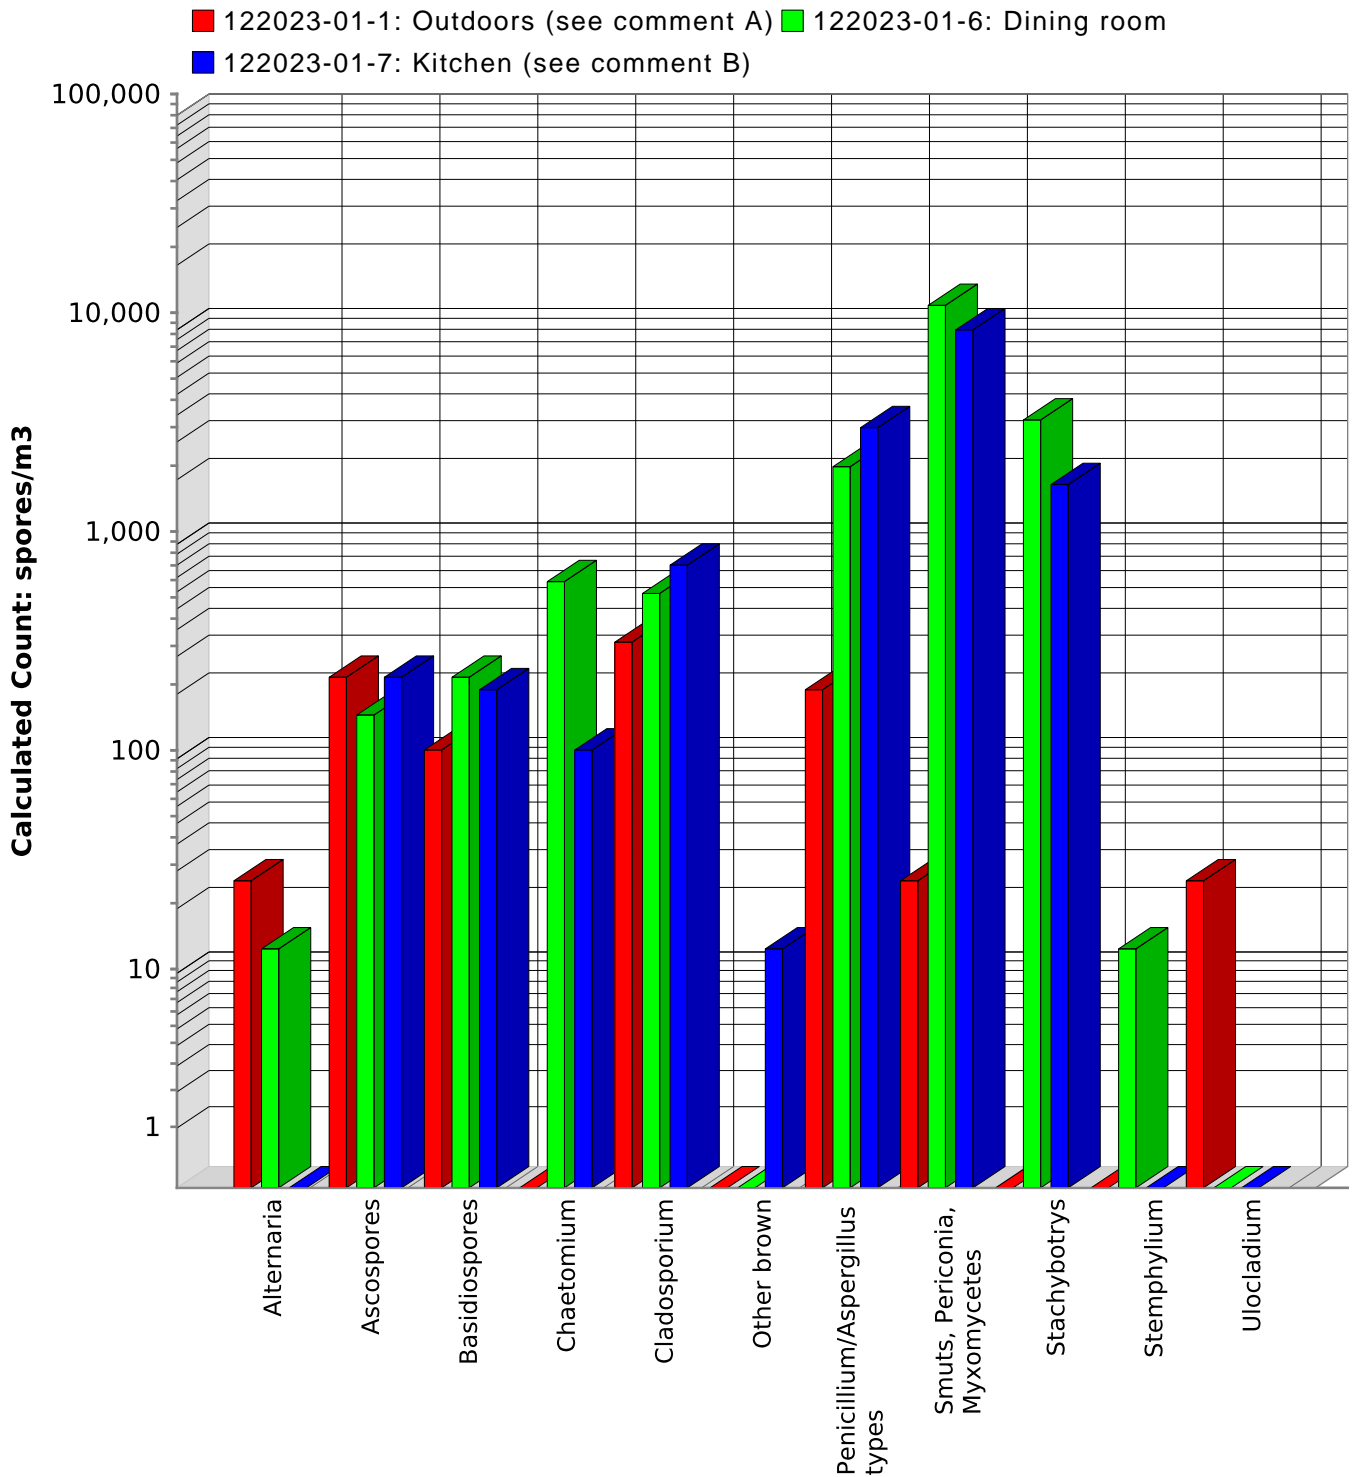
### SPORE TRAP REPORT: NON-VIABLE METHODOLOGY

**Comments:** A) 6 of the raw count *Cladosporium* spores were present as a single clump. B) 14 of the raw count *Penicillium/Aspergillus* type spores were present as a single clump.

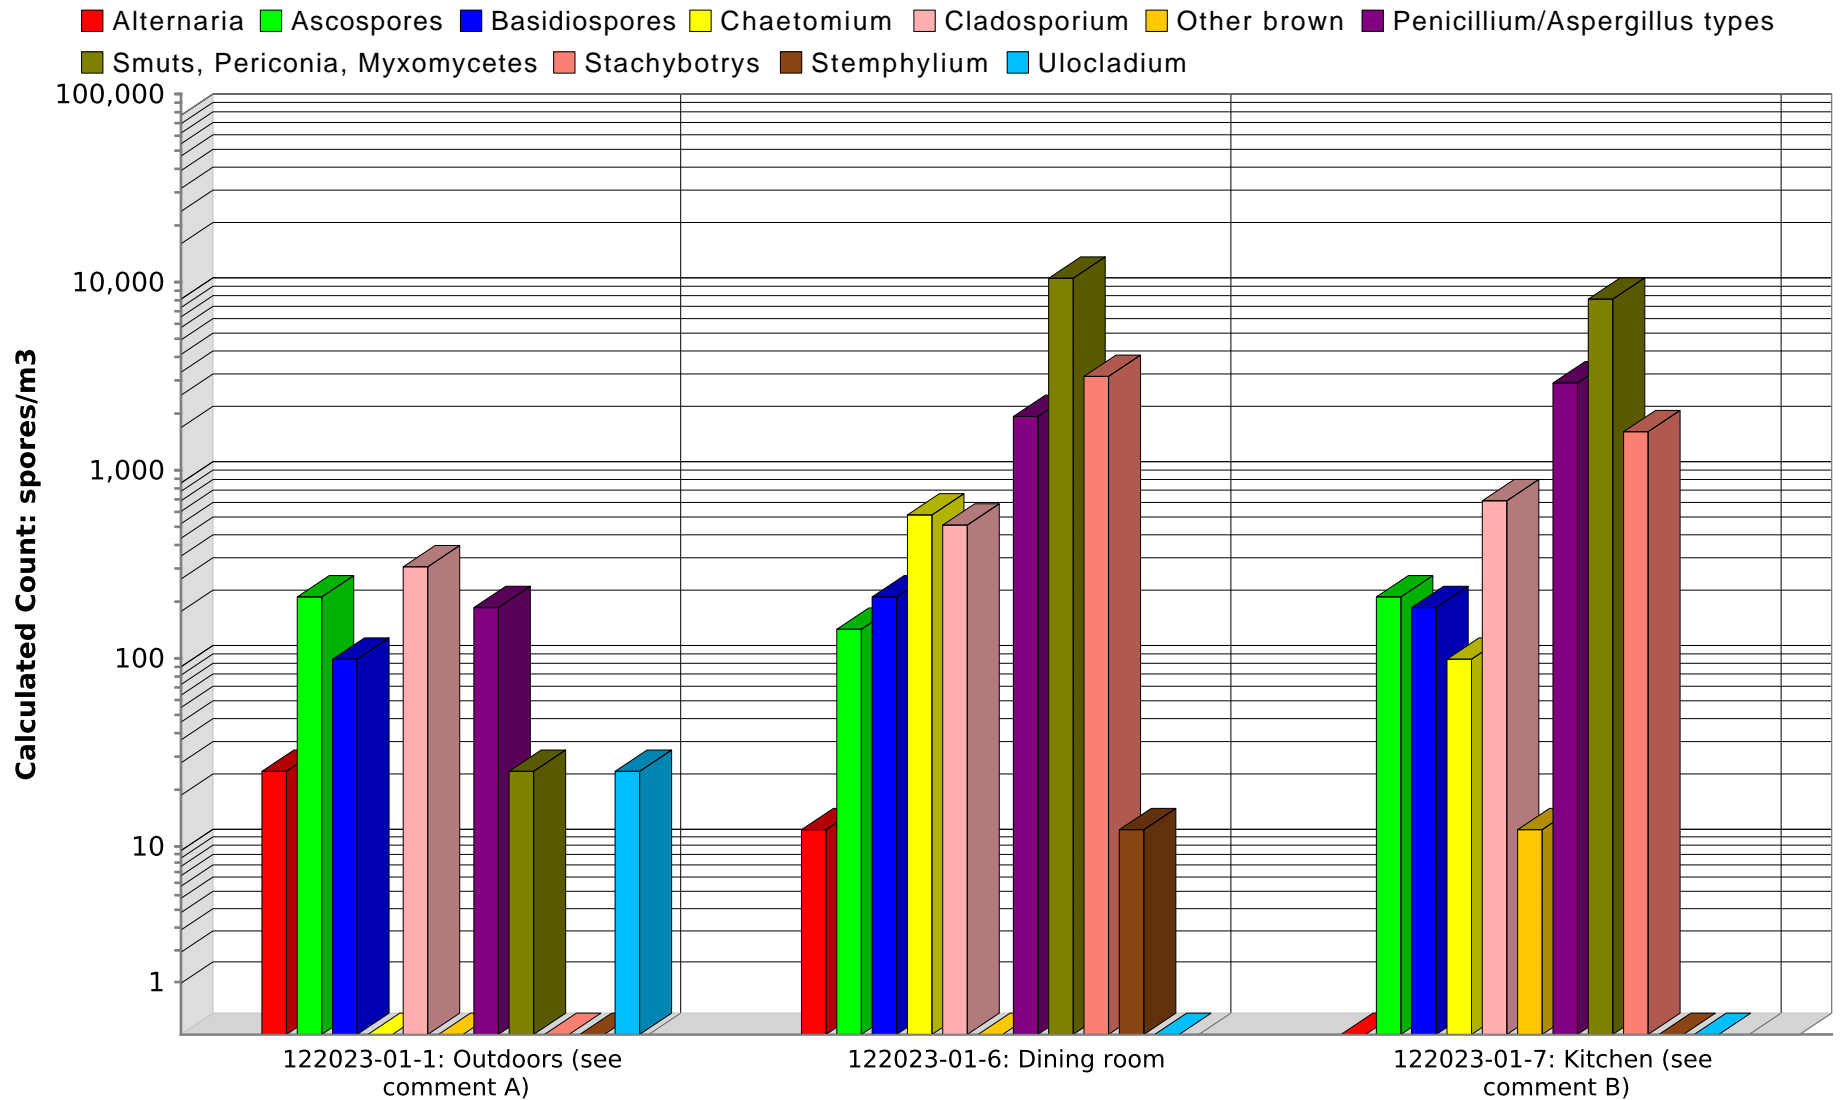
### SPORE TRAP REPORT: NON-VIABLE METHODOLOGY

**Comments:** A) 6 of the raw count *Cladosporium* spores were present as a single clump. B) 14 of the raw count *Penicillium/Aspergillus* type spores were present as a single clump.
