HOME INSPECTION AUTHORITY LLC 800-950-8184 john@homeinspectionauthority.com http://www.homeinspectionauthority.com

RESIDENTIAL REPORT

3632 Amesbury Rd Los Angeles, CA 90027

Marie Rose Babi AUGUST 31, 2022

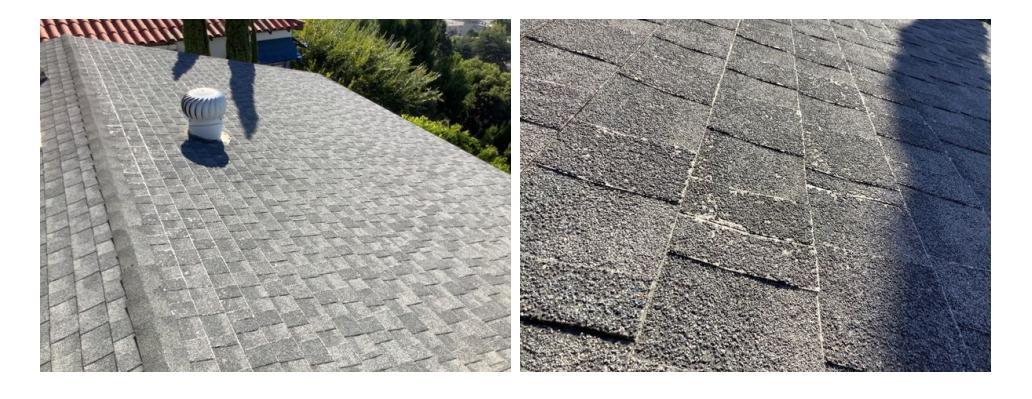
2.2.1 Flashings & Penetrations

OPEN SEAMS AT ROOF PENETRATIONS

Needs Attention Be Advised: Open seams around pipe stack seals or other roof penetrations on roof are visible. This condition will allow moisture intrusion into building which may cause damage to surrounding building materials. Roofing pipe stacks and other roof penetrations need periodic maintenance to ensure they are sealed correctly, after sitting in the sun for so long the sealant or rubber dries out and cracks allowing moisture to enter the building.

<u>Recommend further evaluation by a qualified licensed roofing professional before the end of your</u> <u>inspection contingency period.</u>

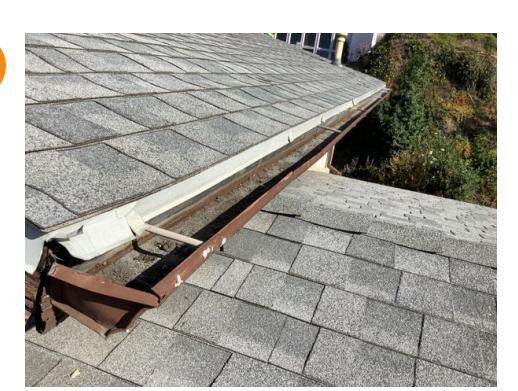
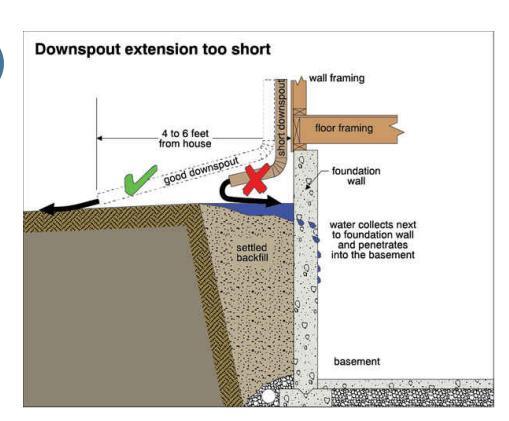
RUSTED GUTTERS

Needs Attention Be Advised: Rain gutters exhibit rusted areas, This condition may result in gutters leaking causing damage to surrounding building materials. This is indication of older materials that may need replacing in near future, rusting is also caused by deferred maintenance allowing gutters to fill with debris.

Recommend further evaluation by a qualified licensed gutter professional before the end of your inspection contingency period.

Contact a qualified gutter contractor

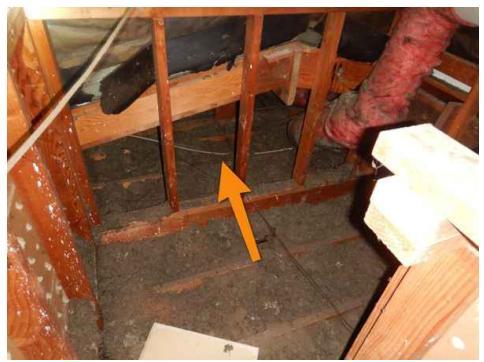
1st Floor Attic

ATTIC ACCESS 1ST FLOOR ATTIC

Needs Attention Be Advised: One or more areas of the attic where not readily accessible at the time of inspection because it was blocked by storage, HVAC system and or ducting. Some attics are also not readily accessible in some areas by design of attic framing. Recommend having this area made readily accessible and have it inspected before the end of your inspection contingency period. Hidden defects may exist in these areas.

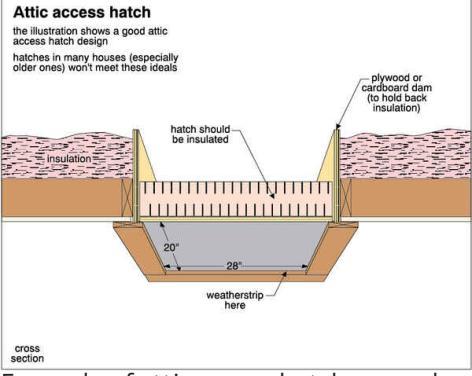
Example of attic access hatch upgrade

5.3.1 Roof Framing System ATTIC ACCESS HATCH UPGRADE

Contact a qualified general contractor.

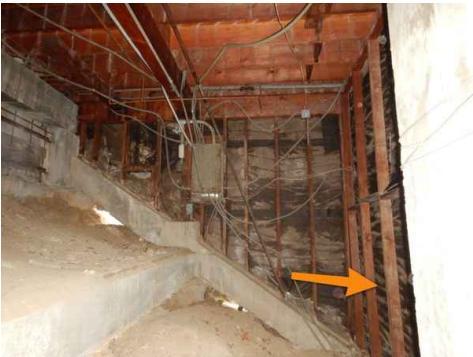
office walls facing crawlspace

WALLS MISSING INSULATION

Needs Attention: One or more walls are missing insulation. This condition may lead to increased heating and cooling costs. Recommend further evaluation by a qualified licensed insulation professional.

Recommendation Contact a qualified insulation contractor.

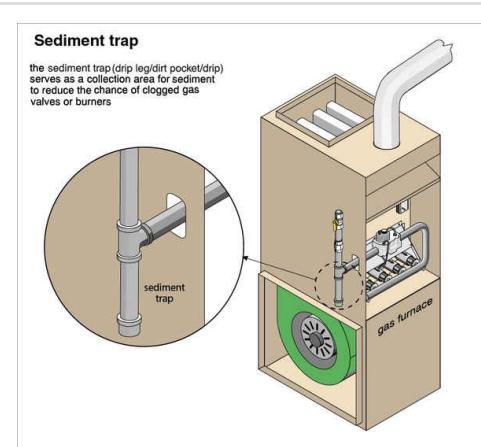
Illustration Example of Sediment Trap

7.1.5 Heating Equipment

MISSING SEDIMENT TRAP

Contact a qualified heating and cooling contractor

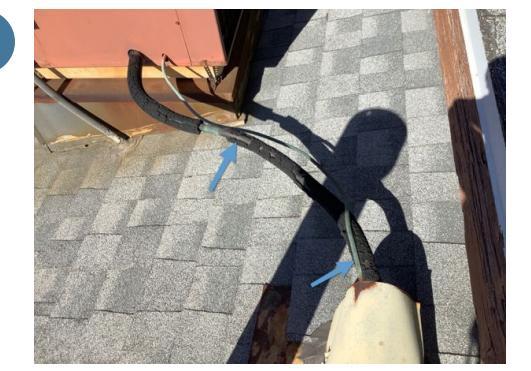
7.4.1 Conditioned Air Distribution Systems **POSSIBLE ASBESTOS HVAC DUCTING** CONDITIONED AIR DUCT SYSTEM

Needs Attention Be Advised: Possible Asbestos Material may be present. HVAC conditioned air duct system may be material that contains asbestos, further evaluation and testing of entire conditioned air duct system would need to be performed to determine this by a qualified licensed abatement contractor. Recommend further evaluation by a qualified licensed professional before the end of your inspection contingency period.

Contact a qualified professional.

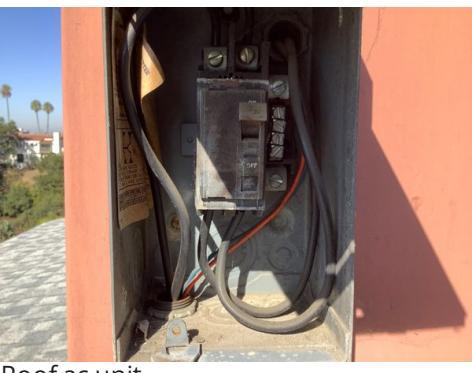
Roof ac unit

Not Acceptable Be Advised: No visible grounding at AC service disconnect located at AC unit at exterior wall. This condition poses an electrical safety hazard and possible damage to unit if not corrected.

Recommend immediate further evaluation by a qualified licensed HVAC or electrical professional.

Recommendation Contact a qualified professional.

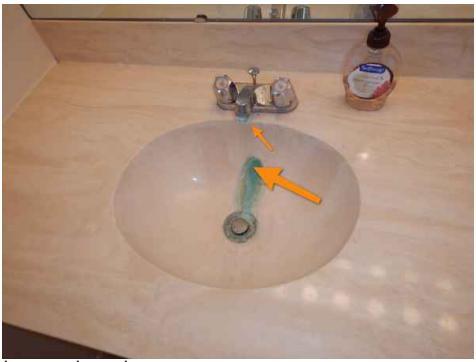
lower level

Not Acceptable: One or more faucets or fixtures are leaking and need immediate repair or replacing by qualified professional. Water leaks can lead to water/moisture damage to surrounding areas if not repaired in a timely manner.

<u>Recommend immediate repair and further evaluation by a qualified</u> <u>licensed professional, hidden damage may already exist.</u>

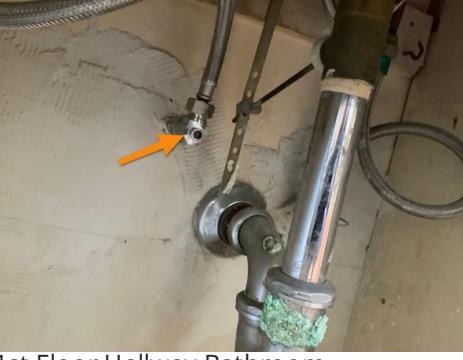
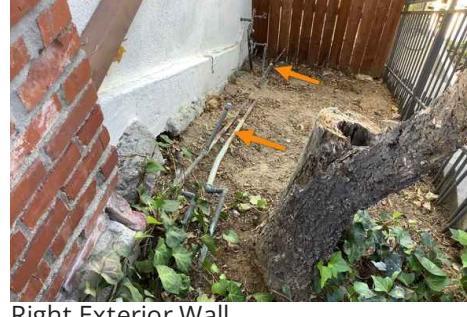
10.2.1 Drain, Waste, & Vent Piping CAST IRON DRAIN PIPE PRESENT PLUMBING SYSTEM

Needs Attention be Advised: Cast iron & galvanized steel waste & vent pipe is present in the plumbing system. These materials were used widely throughout early 1900's till approximately late 1970's when ABS plastic became the more popular drain pipe to use. You can expect to do repairs on these older type of pipes in the future as they have reached the end of their serviceable life expectancy and will eventually deteriorate and leak over time.

Contact a qualified plumbing contractor.

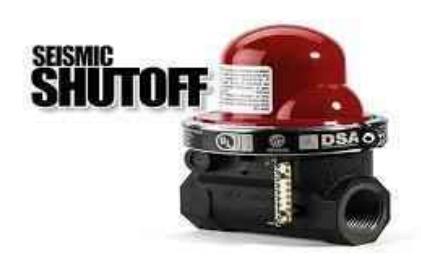
Example of seismic shut off valve

10.3.1 Fuel Gas Piping SEISMIC SHUTOFF VALVE **NOT PRESENT**
